# NORTHRIDGE EARTHQUAKE: LIFELINE PERFORMANCE AND POST-EARTHQUAKE RESPONSE

Technical Council on  
Lifeline Earthquake Engineering,  
American Society of Civil Engineers

Edited by Anshel J. Schiff

April 1997

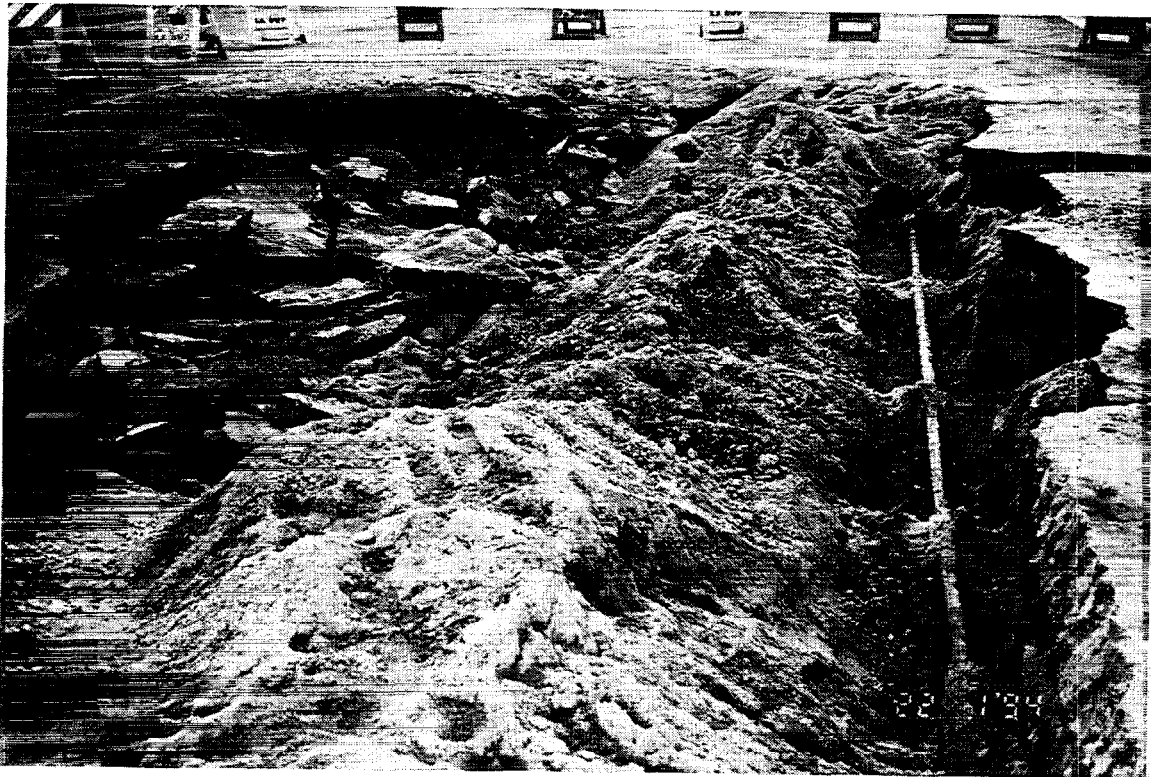
Fig. 6.6. Gas explosion led to fire, busted water mains and severed communications cables.

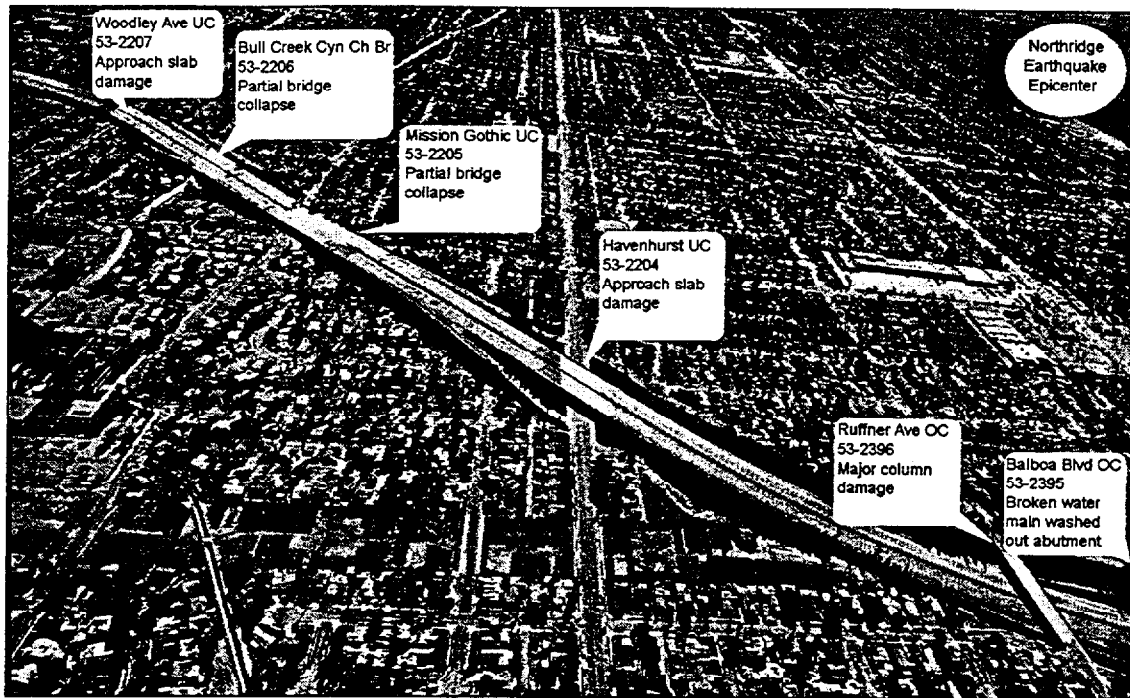
Figure 7.11. Bridge Damage at Location #3 -Route 118 west of Route 405.

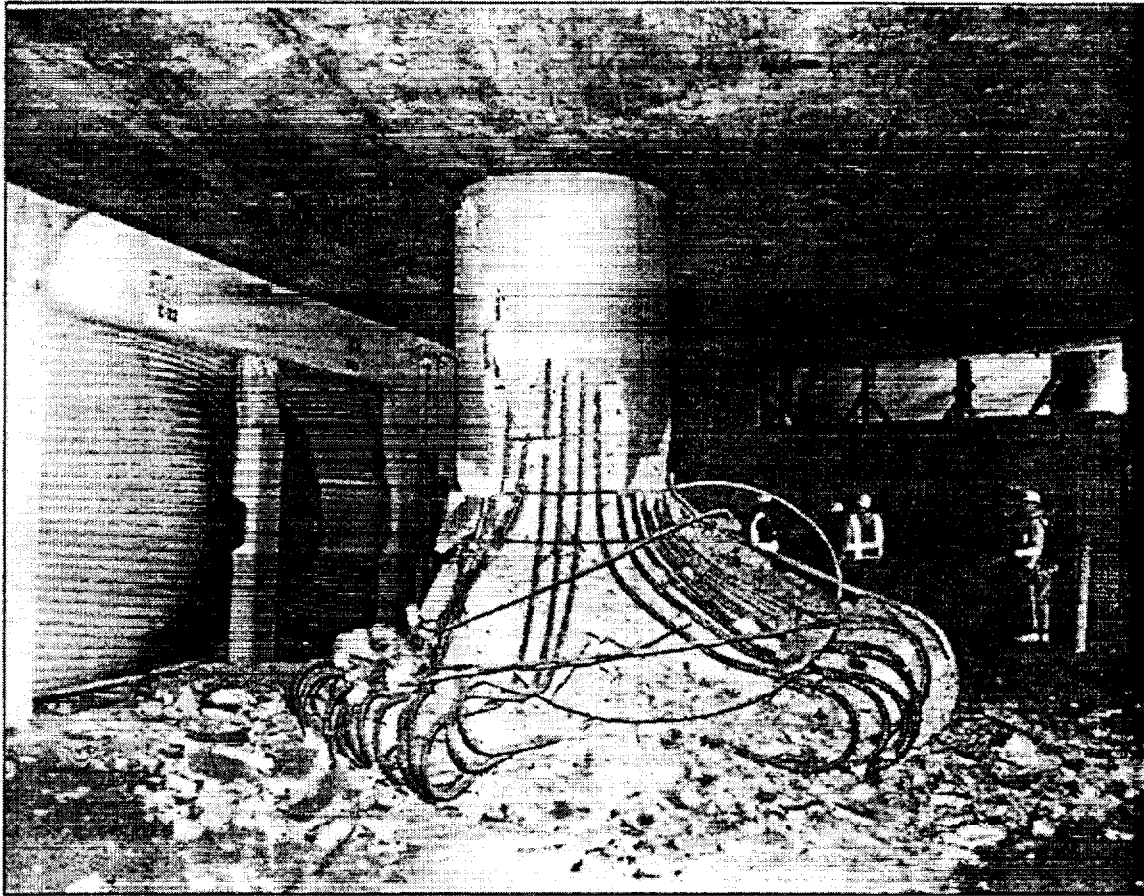
Figure 7.18. Damage to La Cienega-Venice Undercrossing.

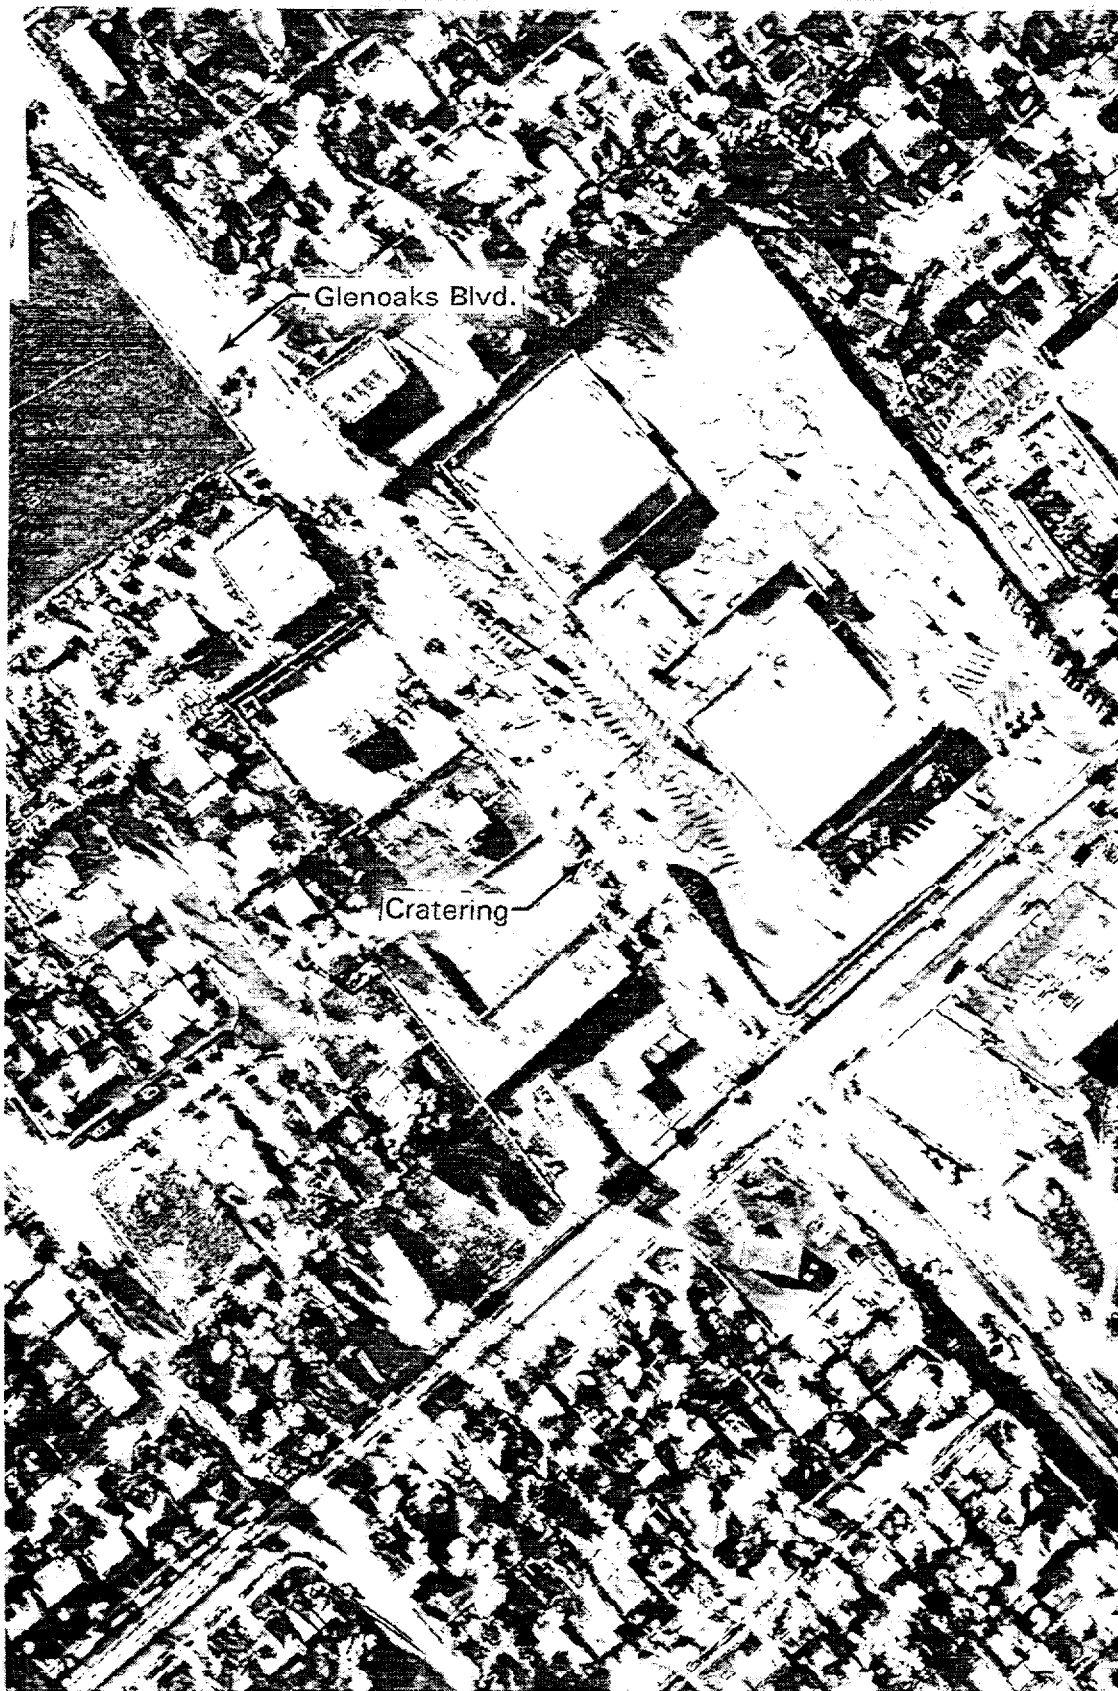
Fig. 14.2 Cratering caused by gas leakage and explosions along Glenoaks Boulevard after the 1971 San Fernando Earthquake.
